AN INVESTIGATION OF THE LATCH MECHANISM OF SAFETY DOORS OF A BARREL TILTING MACHINE

DRAFT REPORT OF

Dr Colin Goodchild C. Eng. MIEE

September 12, 1995

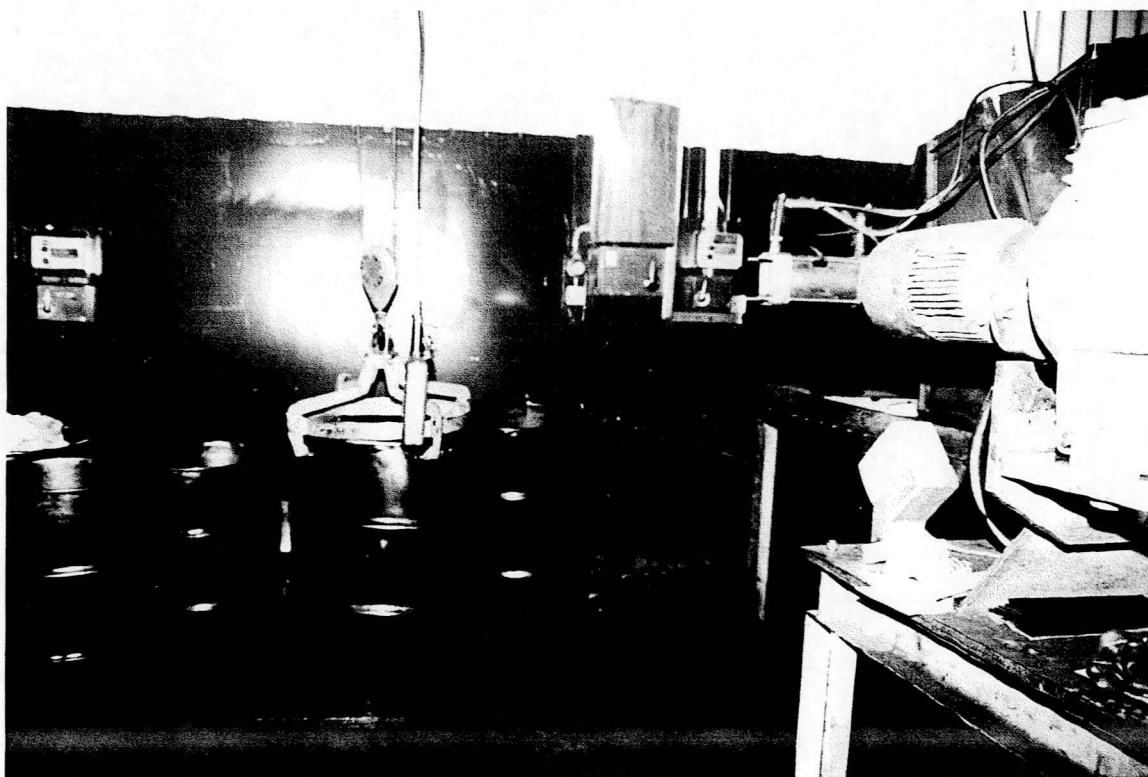
5/9/95-A46

Photographs 5/9/95-A46, 5/9/95-A47, 5/9/95-A48 and 5/9/95-A49 is a sequence of pictures showing the process of loading a barrel with the overhead gantry hoist and the platform tilting from the base position to the fully raised position were the barrel discharges its contents.

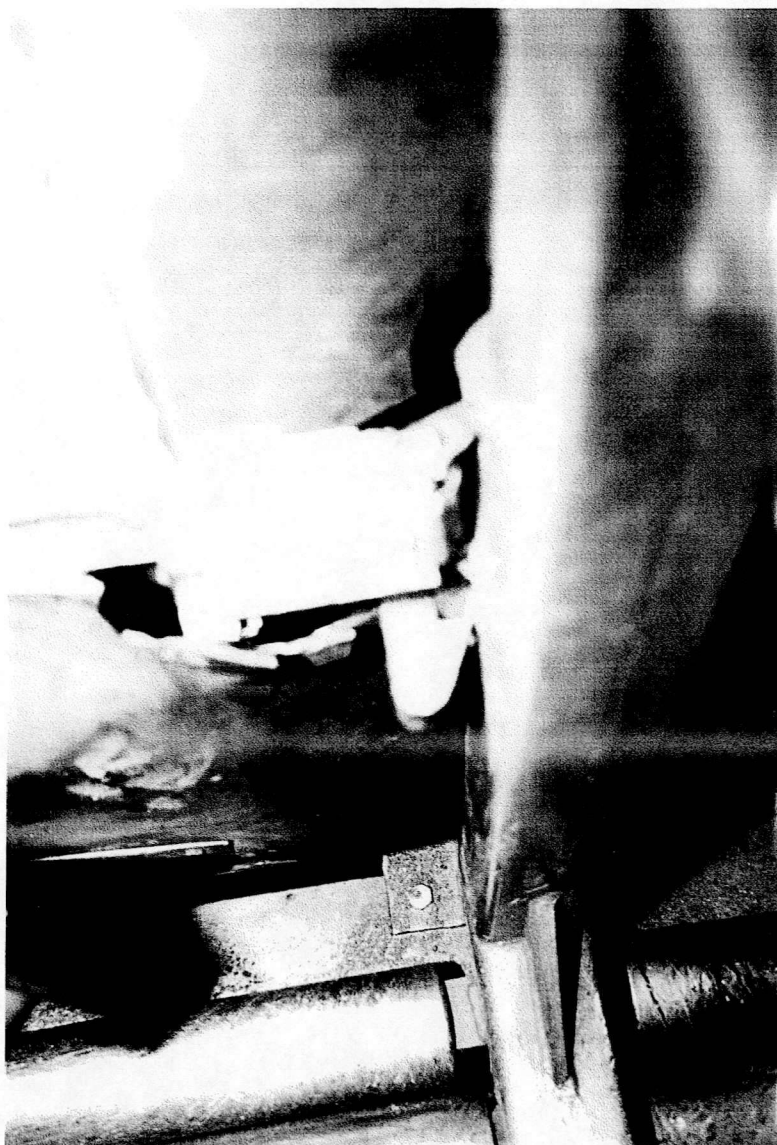
Photograph 11/9/95-A413 Shows the manually operated door latch in the locked safety door position. The interlock limit switch above the latch has the switch lever pushed counter clockwise to cause the union of the limit switch contacts.
